## Marine Safety Information Bulletin Sector Los Angeles – Long Beach

MSIB Number: 01-22  
Date: Jan 12, 2022  
Staff Symbol: spv  
Phone: (310) 521-3770  
Email: seclalb@uscg.mil

### Pilot Boarding Platform Improper Installation and Failure

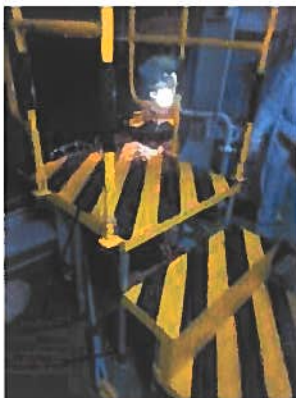
The vessel's pilot boarding area housed a platform approximately two and a half feet tall for accessing the Jacob's ladder. A locking pin that would normally secure the platform to the deck was loose due to improper installation. When the pilot stepped over the side of the vessel to climb down the Jacob's ladder, the loose locking pin gave way and caused the platform and pilot to fall into the water.

Fig. 1: Pilot boarding platform

- Ensure all stanchion locking pins are fully inserted and secured with a cotter pin or safety swivel.
- Maintain accommodation ladders, Jacob's ladders, and vessel boarding platforms.
- Periodically inspect the condition of the vessel's boarding equipment replace it when necessary.
- Assign a crewmember to conduct a safety inspection of the pilot boarding ladder and related equipment after it has been set up and prior to use.

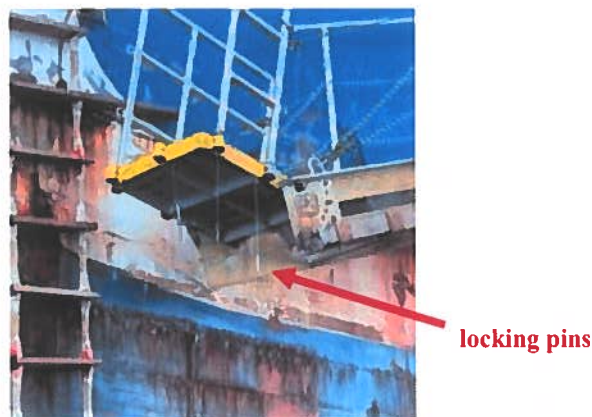
In a separate incident that occurred on January 3<sup>rd</sup>, 2022 a vessel pilot attempted to board foreign flagged vessel via an accommodation ladder and noticed that the locking pins used to secure the railings to the ladder were not in place.

Fig. 3: Accommodation ladder with unsecured locking pins.
